TOPIC: Isolation Transformer
IDENT NO: 10-001
SUPERSEDES: New
DATE: July 15, 2006

SUBJECT: Isolation Transformer - Digital Timing/Tach Indicator Issues

MODELS AFFECTED: F1/F2 Units

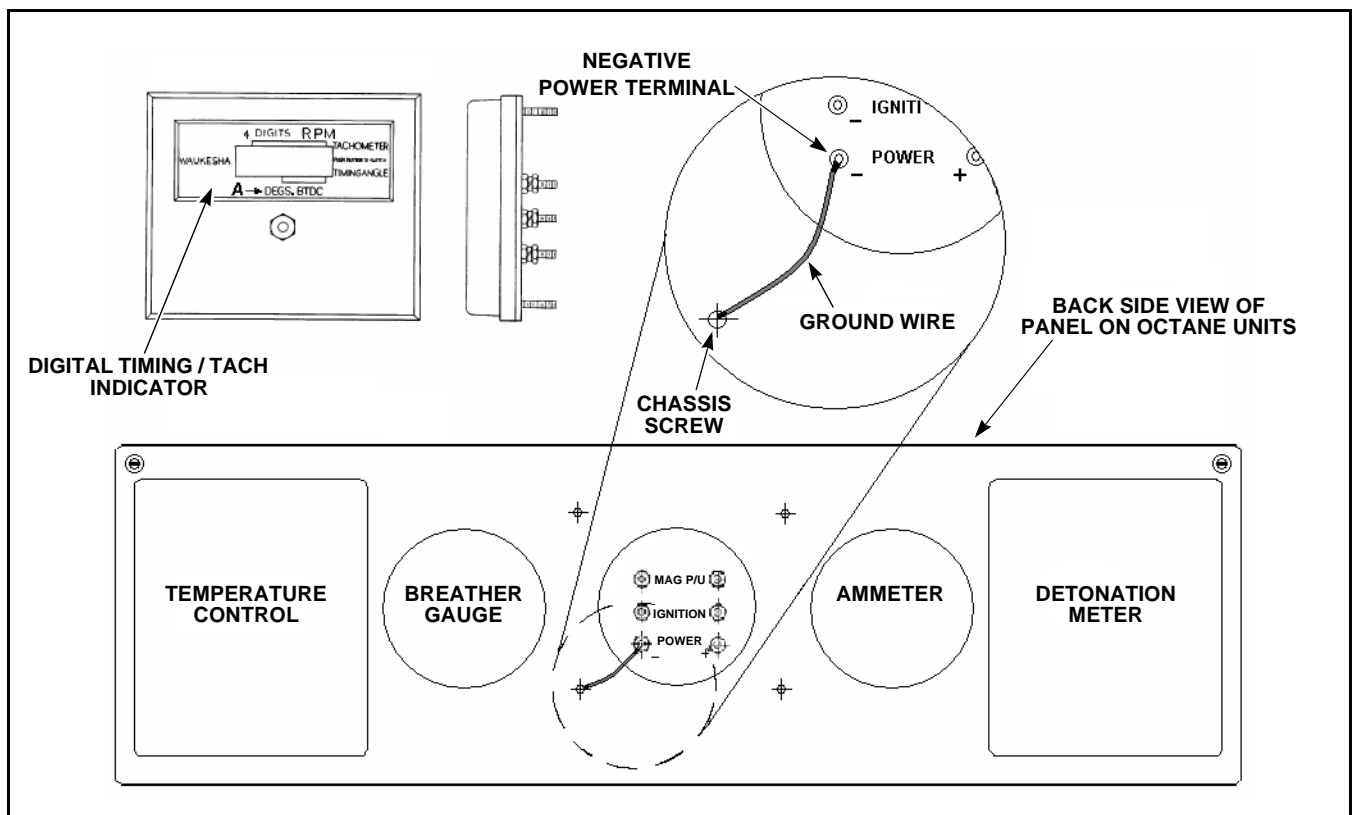
Figure 1. Digital Timing/Tach Indicator

Overheating can be caused by grounding issues with the Digital Timing/Tach Indicator (P/N 111697). The isolation transformers inside the instrument panel may overheat and melt the transformers plastic casing. As a result, the Tach indicator will display incorrect timing or not function at all.

1. Verify unit is in OFF position. Turn OFF main power to unit.
2. Open instrument panel by lifting front cover.
3. Locate negative power terminal on back of Digital Timing/Tach Indicator. Unscrew terminal and remove ground wire (see Figure 1).
4. Tighten negative power terminal after ground wire is removed.
5. Unscrew chassis screw and remove opposite end of ground wire.
6. Tighten chassis screw.
7. Discard ground wire and close panel.
8. Turn ON main power to unit.
